# ⚠️ Product Safety Recall
Re-Work Instructions

Nyby – 5 Litre Galvanised Bucket

NY6616

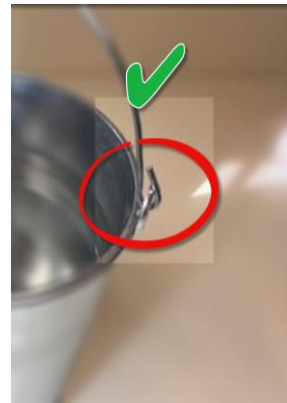
The Modification. The manufacturing process missed a step to bend the rod back towards the handle in a curved (arc) shape so that is does not cause a protrusion that can potentially cause injury. The picture below on the left shows the handle connection before re-work. The picture below on the right shows the handle after re-work is completed. Note that after re-work the protruding end has been rectified by bending it back towards the main handle. This requires a simple bend on each side of the bucket handle that is quick and easy to perform within the centre.

Before re-work   After re-work

Procedure: Use the pliers to close the end of the protruding rod back to the main handle as shown below.
